# ROOF CONDITION REPORT

BUILDINGS A & B | PBR METAL PANEL ROOFS

## Commercial property

August 11, 2026

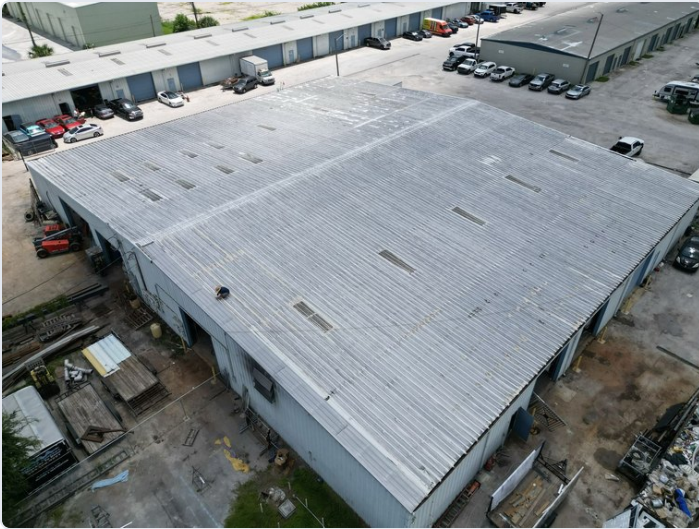
- 01 Overall view of the A roof — 19,232 SF of PBR panel on a single ridge, previously coated, with translucent light panels set in rows across both slopes.

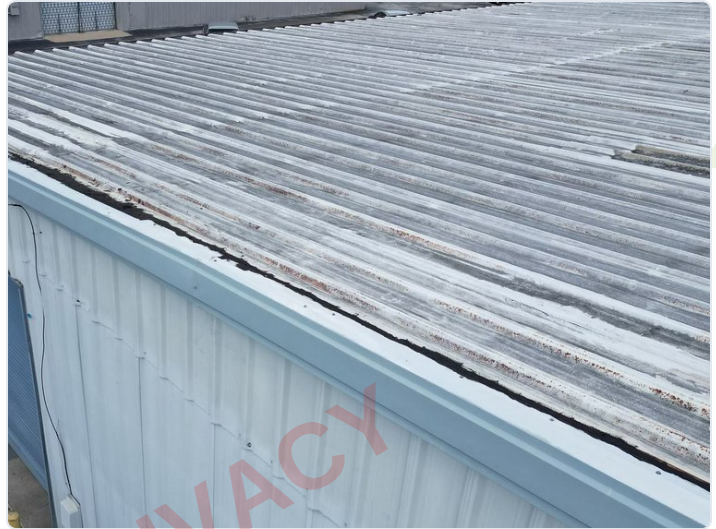
- 02 Eave condition — rust bleeding through the coating along the major ribs and pans, with the coating separated and lifting at the eave termination.

The coating on this roof is no longer protecting the panels. It has weathered through in the field, released at the eave, and corrosion that began at the fasteners and laps is now bleeding through it — the condition documented here is what rules out a further coating application.

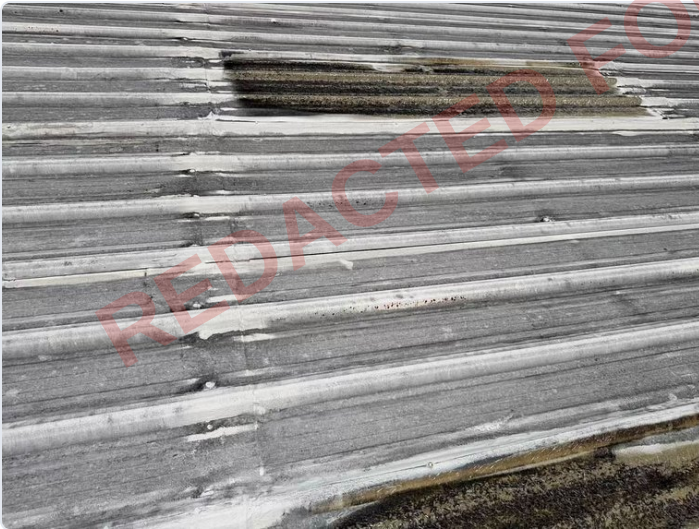
- 03 Coating loss in the panel field — the coating has weathered through and released, exposing corroded base metal beneath.

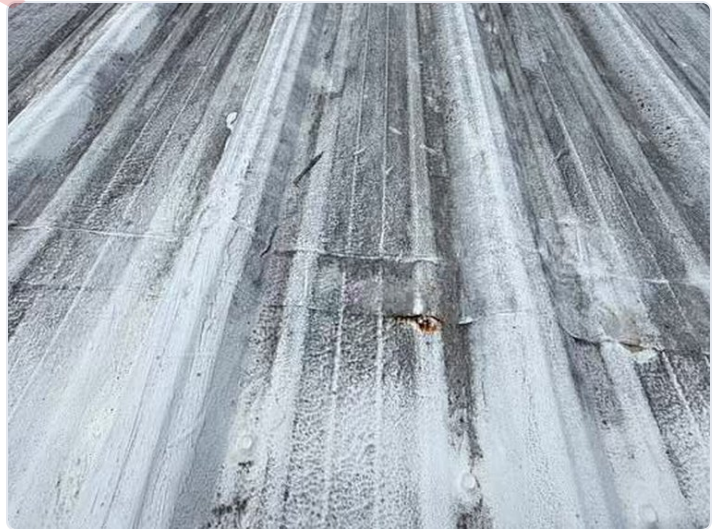
- 04 Corroded fastener at a panel end lap, with rust staining bleeding down-slope through the coating. A prior coating patch is visible at the same lap.

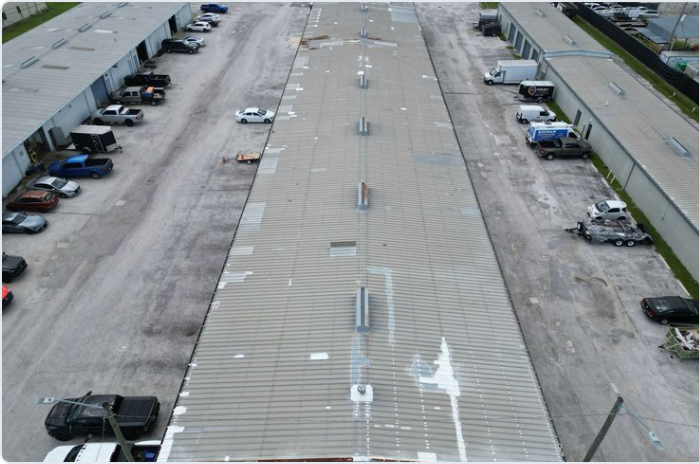
05 Overall view of the B roof — 18,561 SF of PBR panel. White silicone repairs are distributed across the full length of both slopes.

The distribution of the repairs is itself a finding: sealant has been applied at fasteners, end laps, penetrations, and light panels across the entire roof, not at isolated locations. This is the signature of a system-wide condition being chased detail by detail, and it is consistent with the reported recurrence of the leaks.

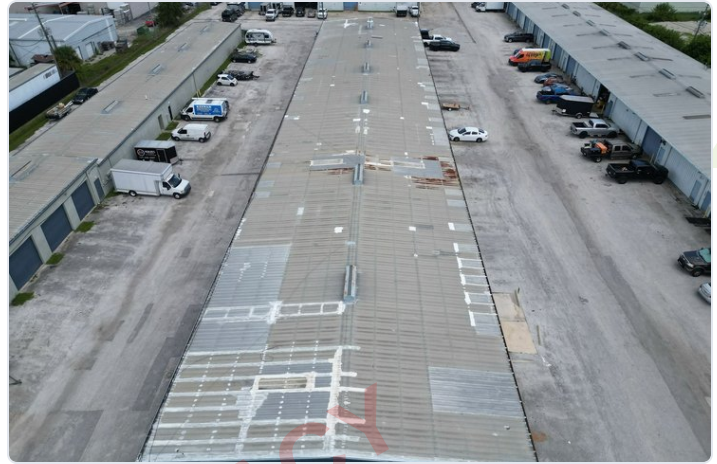
06 Opposing view — the density and spread of the repairs, with rust staining visible at the end-lap lines between them.

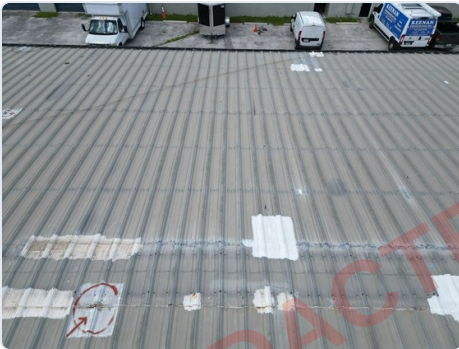
07 Silicone applied along the end-lap lines, with a leak location marked in paint by on-site maintenance.

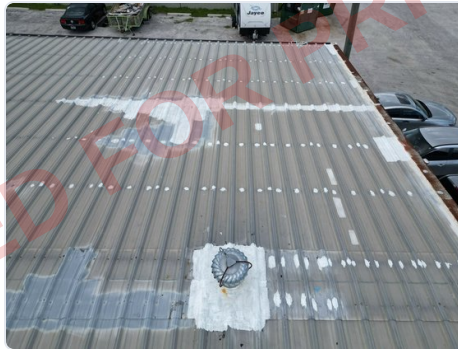
08 Fastener heads individually dabbed with sealant, and a heavily encapsulated ventilator curb.

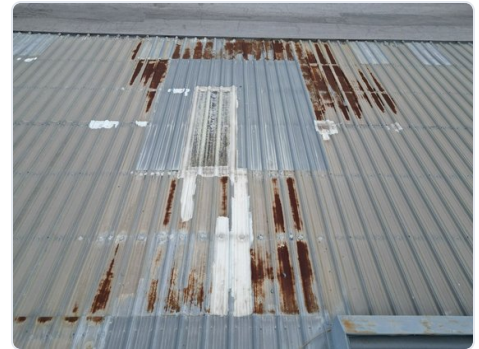
09 Corrosion advancing at the end laps, with silicone applied over a translucent light panel and the panels around it.
